HARDWARE ERROR
 Advant Controller 450
 Older Product Revisions of PM511 can cause slow performance on MB300 or MVI

Advant Controller 450 *2.0/all revisions
 Advant Controller 450 *2.1/all revisions
 Advant Controller 450 *2.2/all revisions
 Advant Controller 450 *2.3/all revisions

PM511V08/PM511V16 (PR:A or PR:B)

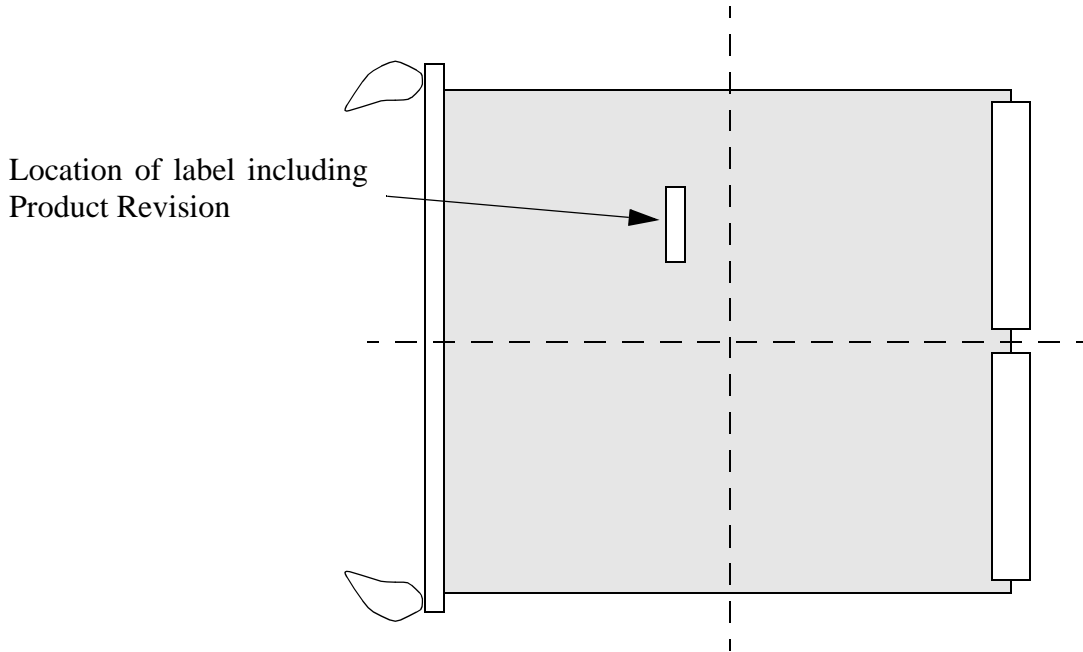
Figure 1 below indicates where the Product Revision label is located on PM511V08 or PM511V16.

Figure 1 Location of Product Revision label on PM511V08 or PM511V16

Return the PM511V08 or PM511V16 with Product Revision A or B, using the RMA (Return Material Authorization) handling and specify that the module needs to be upgraded to Product Revision C or higher.
