Communication Test between ABB Wireless network and AC800M Controllers

ABB Ltda		Doc. no.		Lang.	Rev. ind.
		1KBR200XXXD003		pt	01
				Page	1
				No. of p.	7

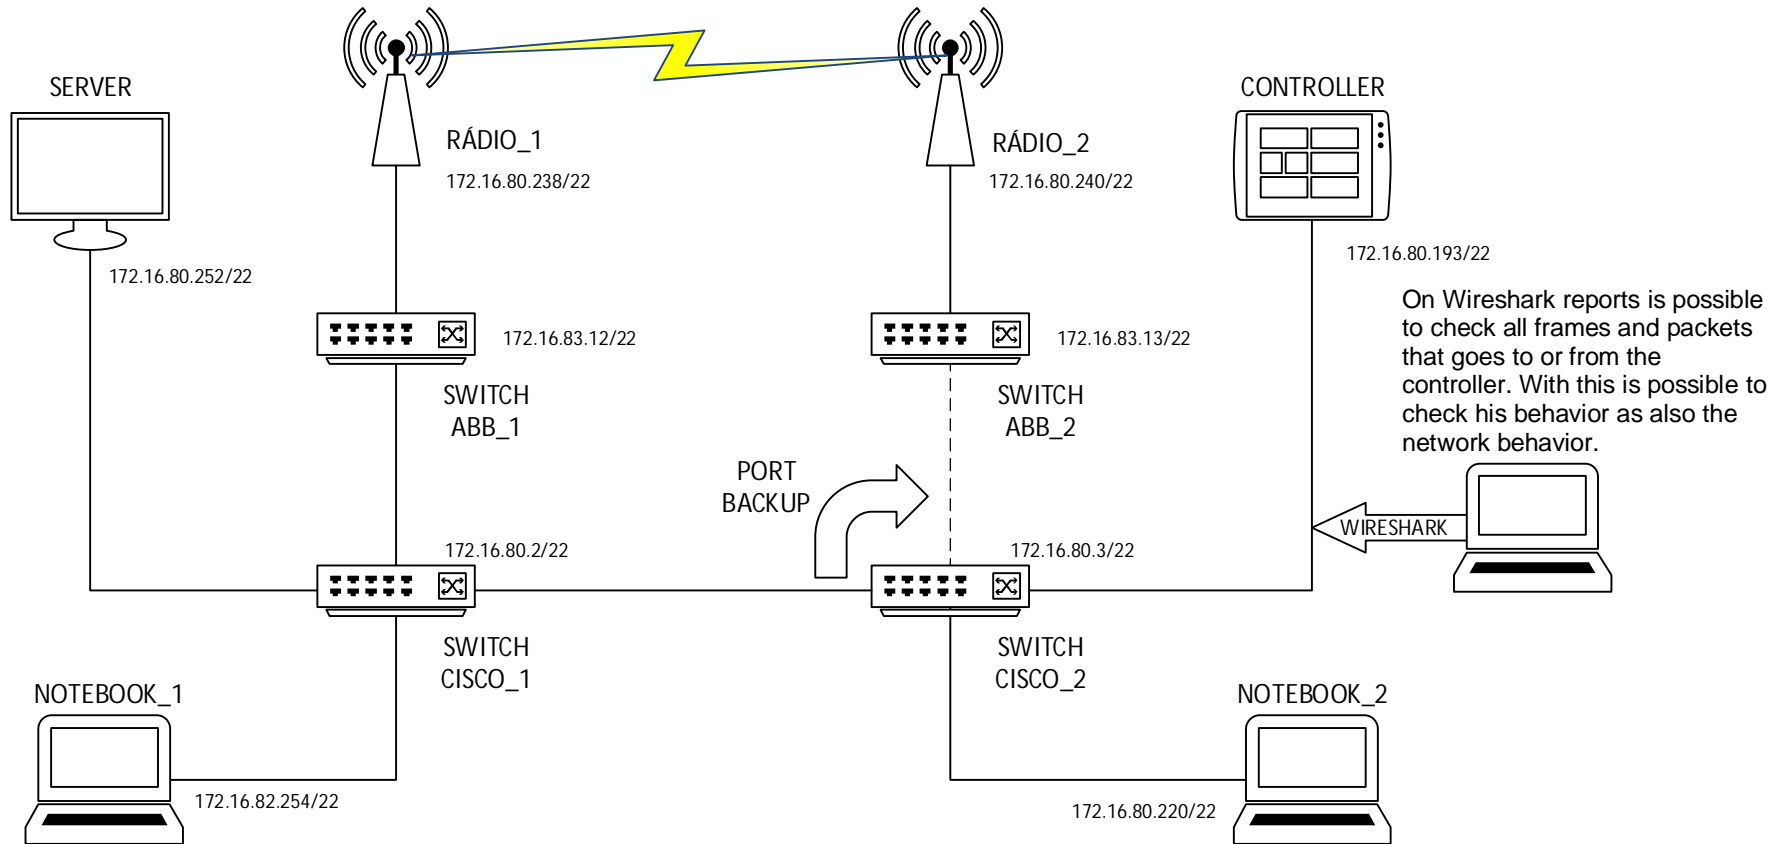
On the diagram we have the basic setup and devices connections.

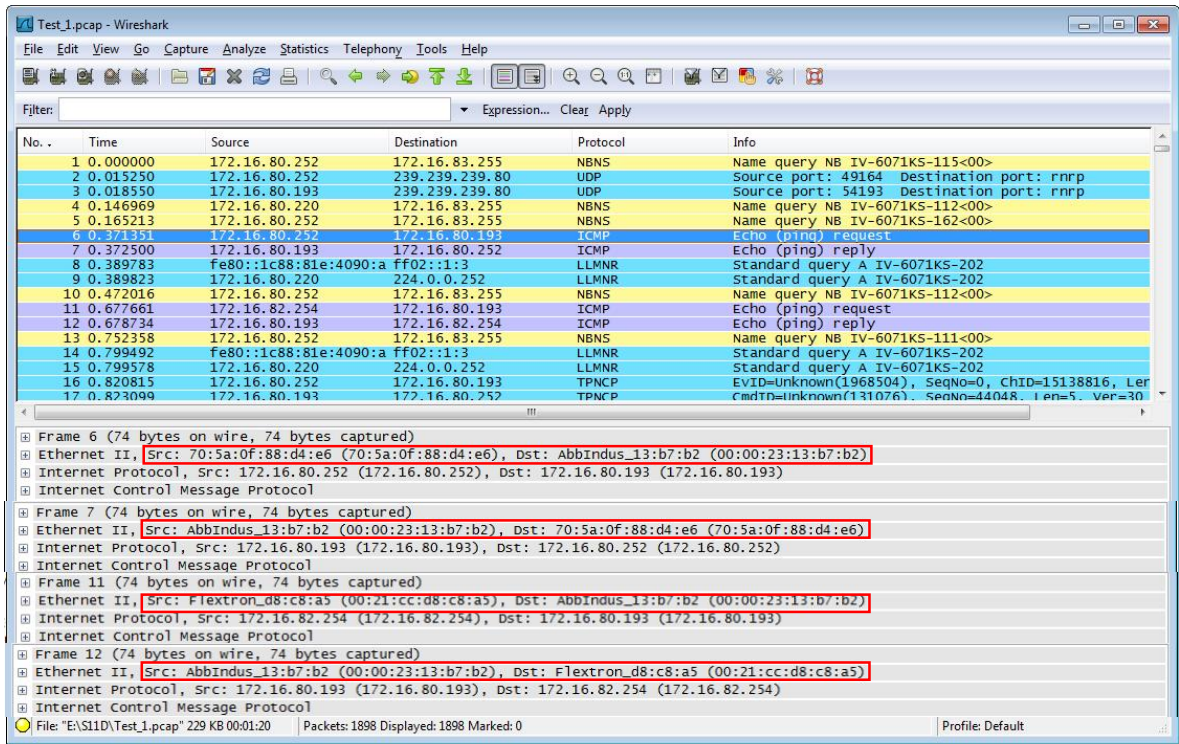
Normal behavior:

Both MAC-address (source and destination) are right. i.e.: The source on frame 6 is the destination on frame 7 as the source on frame 7 is the destination on frame 6. The same occurs between frame 11 and 12.

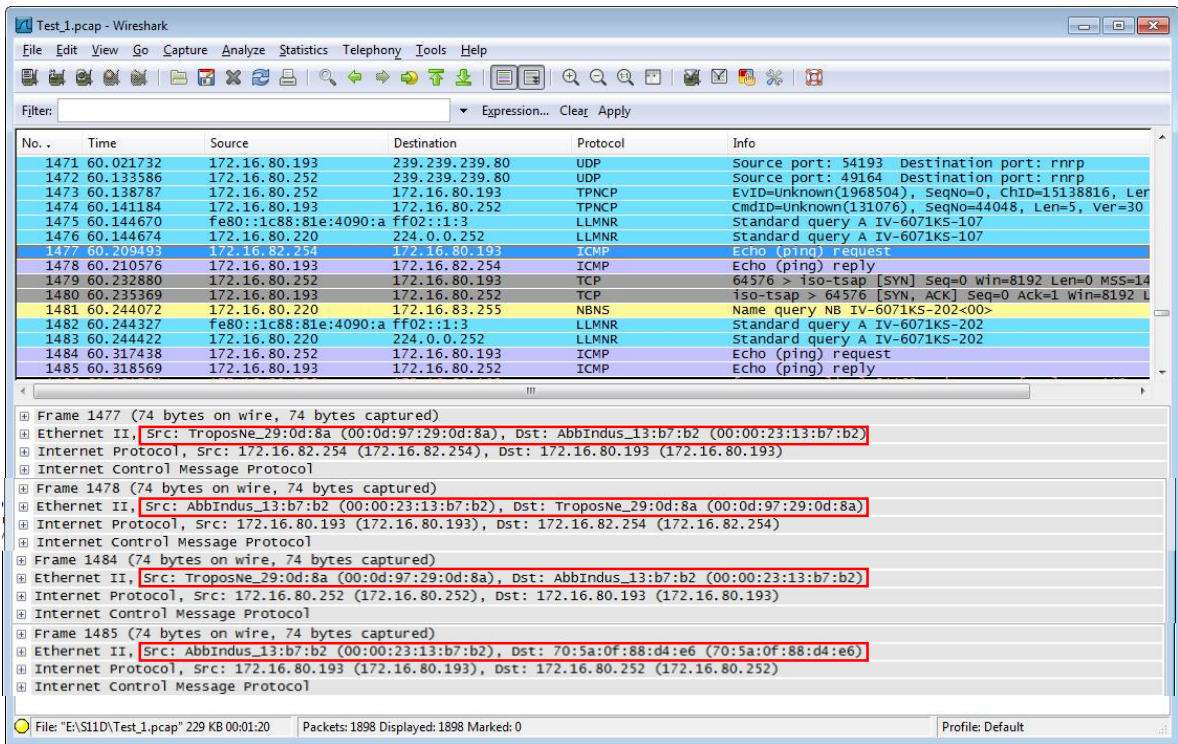
After switching fiber to wireless behavior:

As on the last image, we can see that the behavior is the same between the frames 1477 and 1478, but on frames 1484 and 1485, this didn't occur. The controller (IP 172.16.80.193) receive a frame with the Tropos... source MAC (IP 172.16.80.252 from the server), but, when it answer to the server, it didn't send it with the same MAC just received before, but send it to the MAC 70:5A:0F... (Source MAC from the server before the switching to wireless), what means that the device didn't updated their own ARP table to the address in evidence.

Due to the characteristics of the radios, the frames are "routed" inside the radio, transparently to the user, because it can use a L2 network, as on a switch. However, as on the radio, the frames are routed, there is a MAC change when the frames pass through the radios, as it is expected with this kind of protocol. Because of this, the ARP tables on the devices is updated after some time, as the destinations are not found. After this, the device have their communication reestablished through the other possible path. This is a normal and expected behavior, working with Ethernet networks.

On the specific case of the controller, it keeps on its ARP table, the entry between the last MAC and server IP, it had when working through the fiber. On this way, the controller don't update its ARP table, even receiving frames from the server, with the same IP address but with a new MAC-address.

If we disconnect the communication cable from the controller and after a time like 30 seconds, we reconnect it or even doing a shutdown / no shutdown on the switch port, which has the same effect, the controller, looks like cleans its ARP table and re-learn its connection, allowing it to communicate through the wireless.
